Geoff Cleall's Citroen 2CV Rebuild. (Part 1)

Geoff gives us an insight into his other passion of restoring vintage vehicles.

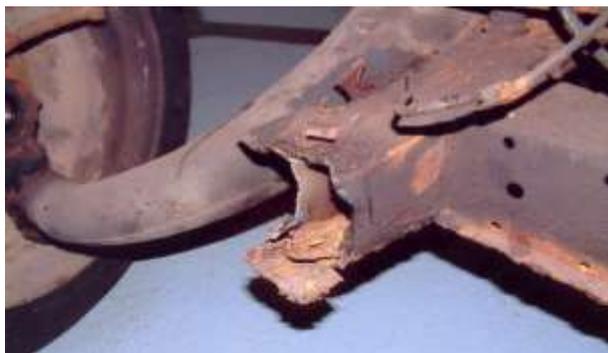
Rust in the chassis and the body tub was now plain for all to see. The forward arms of the chassis were so rusty that one side had bent down under the weight of the engine and the other was so rusty that I could easily bend it by hand. It quickly broke off. (See Pic). No wonder the steering felt heavy with steering column pressed into use in resisting the droop-snoot effect. The sills were shot away together with the bottoms of the 'A' and 'C' posts. The adjacent nearside and offside floors also had holes, one big enough to put a foot through. The inner and outer bulkheads were full of perforations, part of the metal that holds up the rear seat deck had also gone, the rear seat belt mountings had rusted out and there were holes through the spare wheel tray.

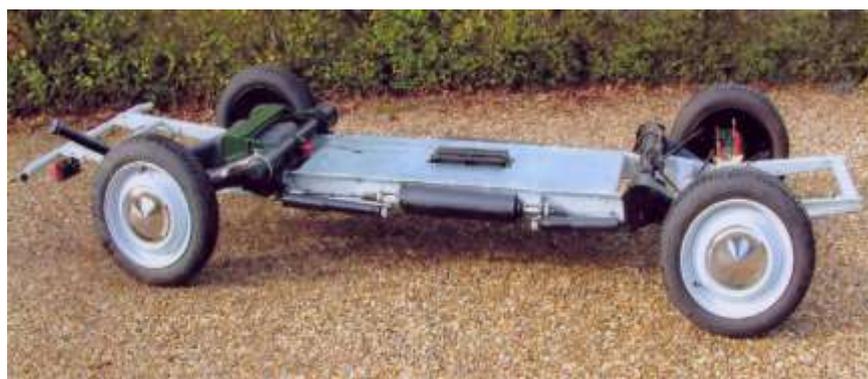
The new galvanised steel chassis arrived (See Pic) and it shows the start of the rebuild. Many people think that the 2CV has torsion bar suspension but the picture shows the actual arrangement. The car has independent suspension with rods coming from the

suspension arms and going into a cylinder shown on the side of the chassis. In the cylinder there are two springs that are linked. When the front wheel hits a bump it rises and pulls the rod which compresses the front spring. That influences the rear spring which, in effect, knows there is a bump coming. You can see the shock absorbers also set horizontally along the side of the chassis. There are no suspension components impinging on the inside of the car.
