# Geoff Cleall continues his Citroen 2CV rebuild

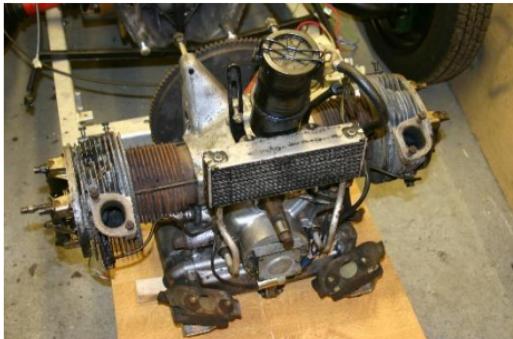
shrunk by immersion in liquid nitrogen, the con-rods and webs are slipped on and it becomes a robust and solid unit once returned to normal temperature. They very rarely fail. The picture shows the engine from the front. The cylinders are finned as are the missing cylinder heads. The substantial oil cooler is mounted across the front.

While beginning to scout around for replacement body panels, I started work on the engine. It seemed to be in good nick having shown excellent oil pressure and no smoke from the exhaust. 2CV engines are pretty bullet proof. They are twin cylinder and are air and oil cooled. The crankshaft/con-rod arrangement is unusual. The one-piece con-rods complete with big-end sleeve have to be fitted to the crankshaft. For this to happen the crank shaft is made up of separate crank pins and webs. The pins are temporarily

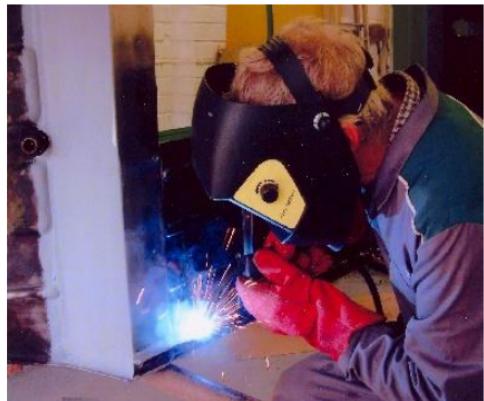
I was able to buy pattern part replacement floors, sills and bulkheads and I welded them in. I cut out all of the other rust and made up the replacement parts from mild steel sheet and welded them in too. I'm a bit short of pictures on this but I've got a picture of me welding in a door sill. The body tub is on its side supported by scaffold tubes running across the garage.

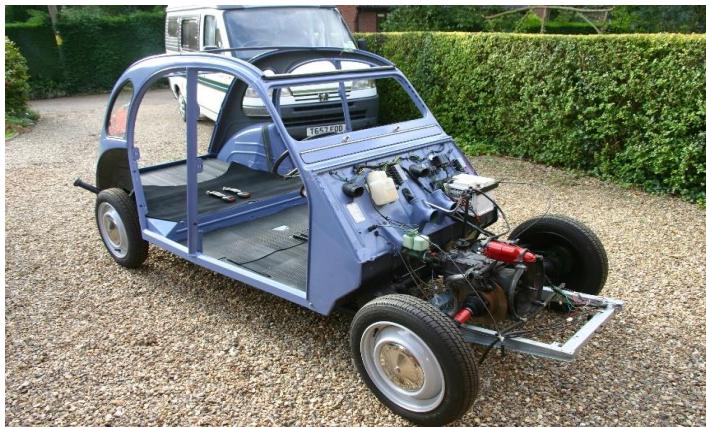
The last pic shows the body tub mounted on the galvanised steel chassis, duly repainted with the re-con gearbox, suspension, brakes and steering fitted. Next, I chased about the countryside tracking down the

Well, the rods that come from the suspension arms to the springs are adjustable in length and by such means it is possible to change the ride height at the front and the back.
