Geoff Cleall's Citroen 2CV Rebuild. (Part 1)

Geoff Cleall continues his Citroen 2CV rebuild

Geoff Cleall finishes his Citroen 2CV rebuild

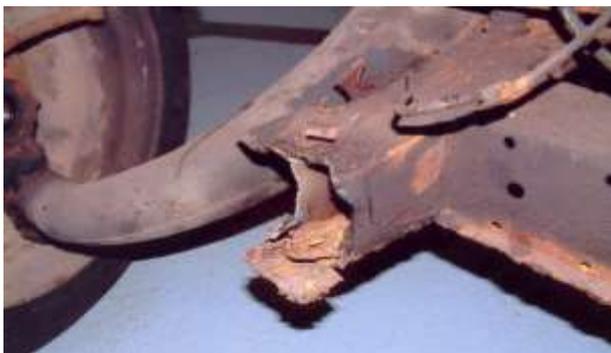
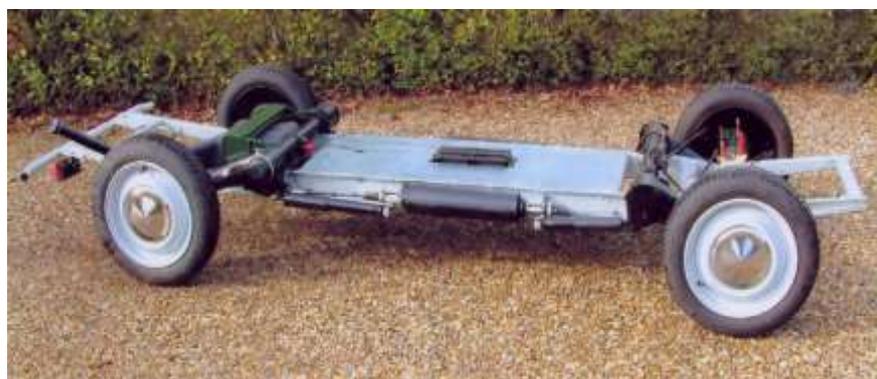
Rust in the chassis and the body tub was now plain for all to see. The forward arms of the chassis were so rusty that one side had bent down under the weight of the engine and the other was so rusty that I could easily bend it by hand. It quickly broke off. (See Pic). No wonder the steering felt heavy with steering column pressed into use in resisting the droop-snoot effect. The sills were shot away together with the bottoms of the 'A' and 'C' posts. The adjacent nearside and offside floors also had holes, one big enough to put a foot through. The inner and outer bulkheads were full of perforations, part of the metal that holds up the rear seat deck had also gone, the rear seat belt mountings had rusted out and there were holes through the spare wheel tray.

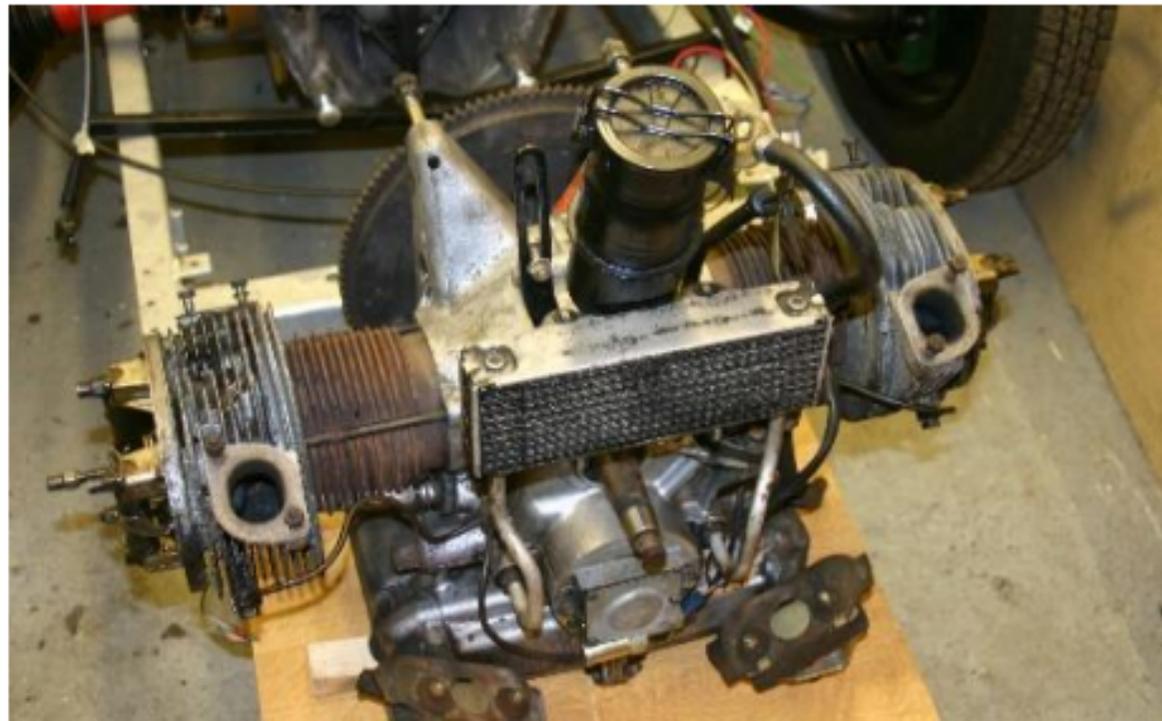
While beginning to scout around for replacement body panels, I started work on the engine. It seemed to be in good nick having shown excellent oil pressure and no smoke from the exhaust. 2CV engines are pretty bullet proof. They are twin cylinder and are air and oil cooled. The crankshaft/con-rod arrangement is unusual. The one-piece con-rods complete with big-end sleeve have to be fitted to the crankshaft. For this to happen the crank shaft is made up

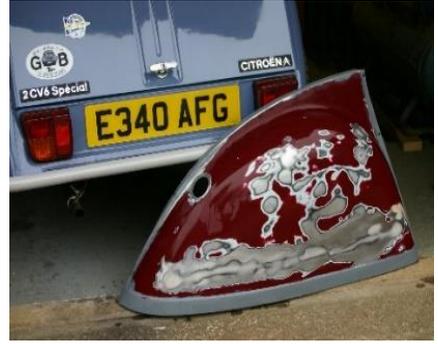
I started to look for second hand replacement panels. I needed a new rear wing and four doors. After contacting the 2CVGB Club, members began throwing them at me and I soon had a good wing and 13 doors to choose from, all in different colours. The

doors were not rusty but with a skin thickness of only 0.7 mm they all had many small dents. They sometimes split along the top edge and getting rid of dents is like working on a large biscuit tin lid. The front doors are on hinges but the rear ones are held on by gravity and can be slid off vertically. I was able to keep the bonnet and that too has no hinges and can be slid off sideways. The existing boot lid was good.
